# Improving Soil Health and Water Quality in the Thames River Watershed

# TLGV Regional Conservation Partnership Program

## Improving Soil Health & Water Quality in the Thames River Watershed

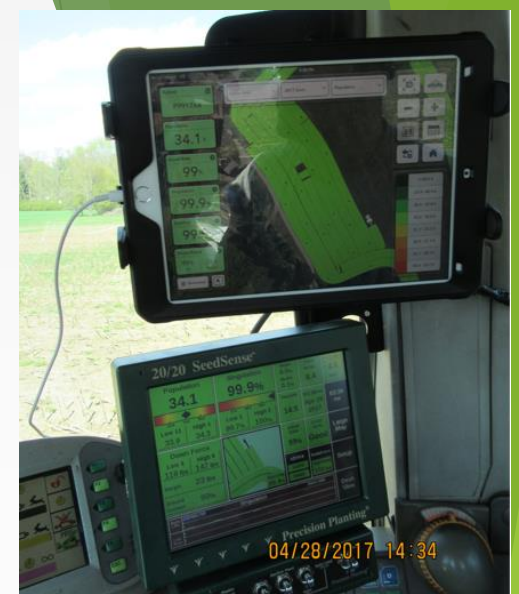
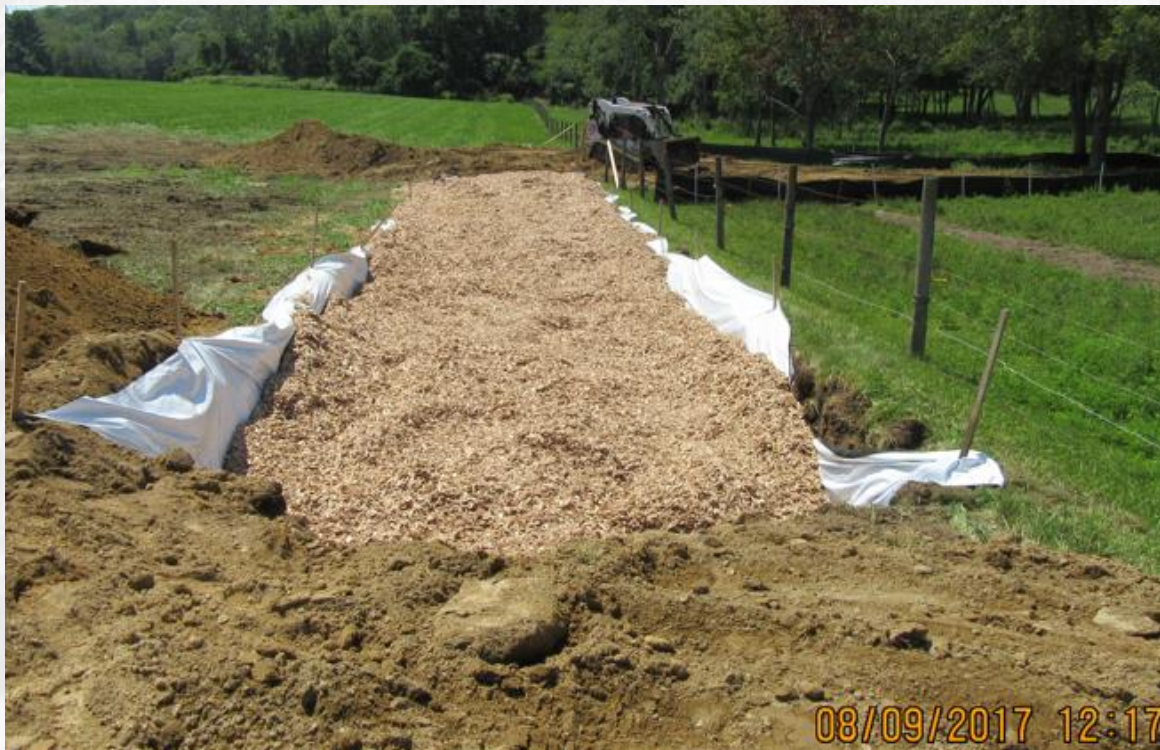
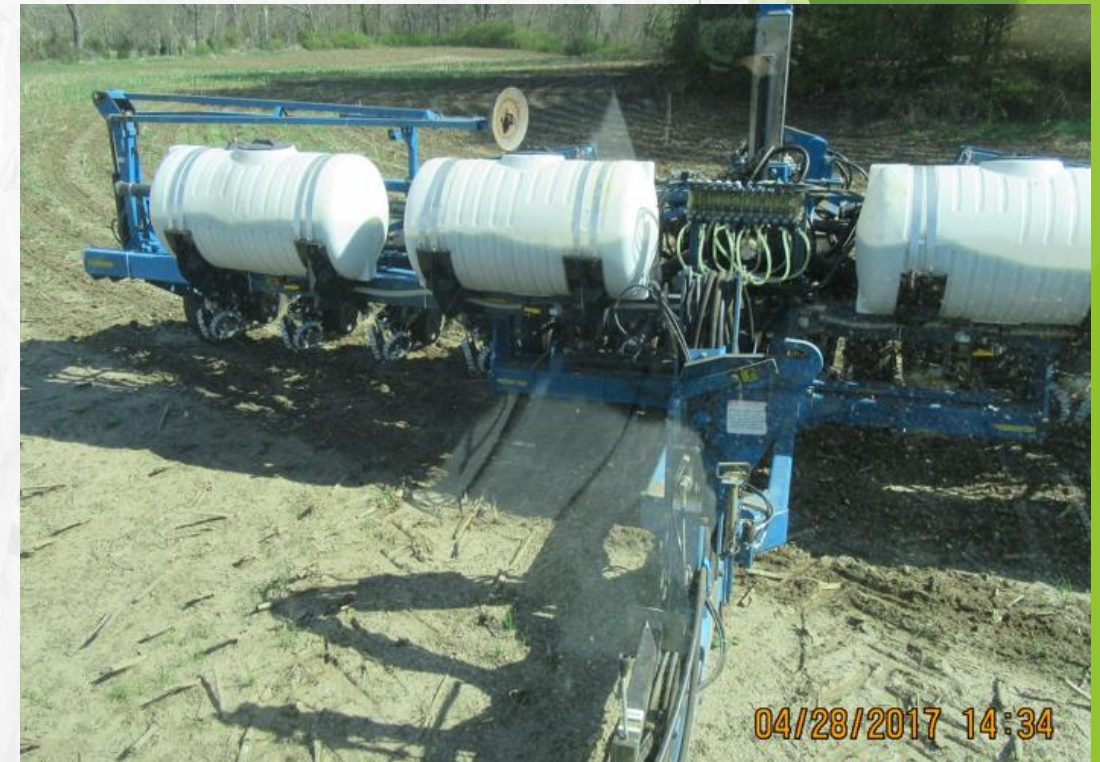
- Little River Water Quality Improvement - Farm Fields Nutrient Reduction Project: constructed a denitrifying woodchip bioreactor and purchased precision planting equipment (PPE) to be used on 650 acres

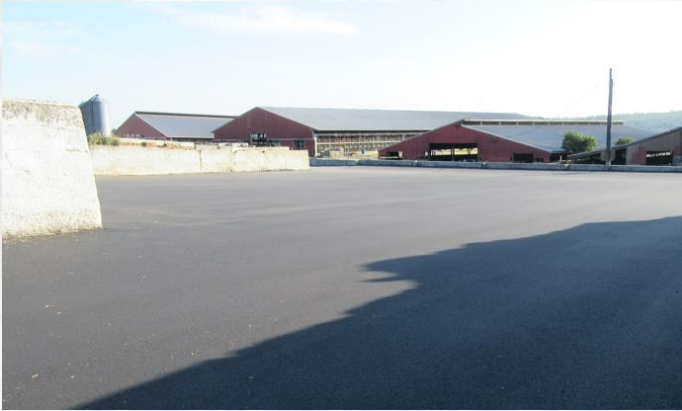
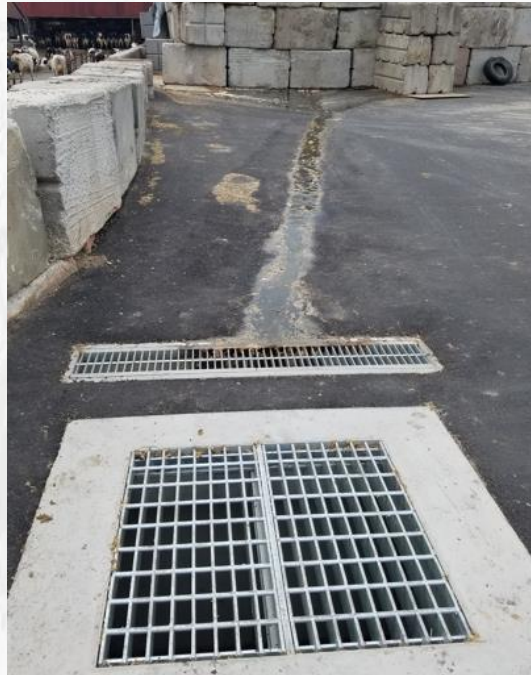
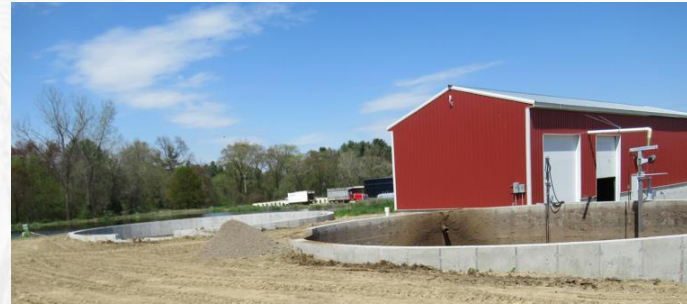
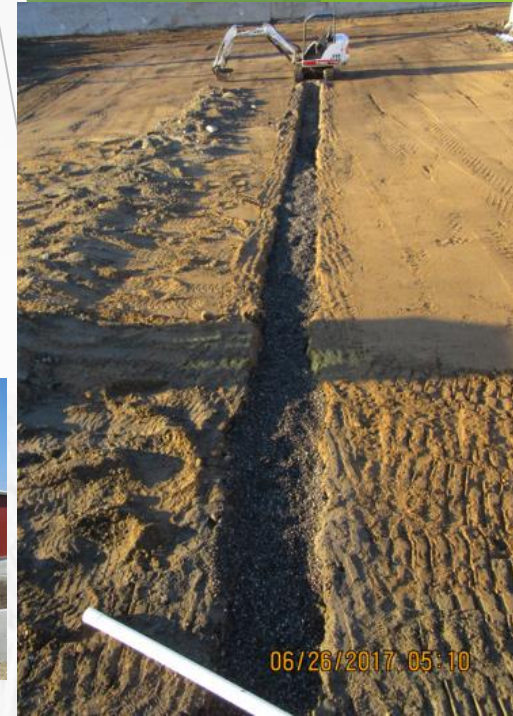
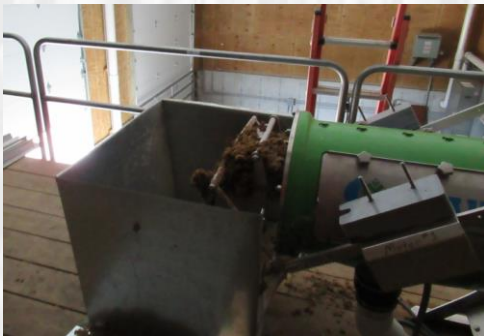
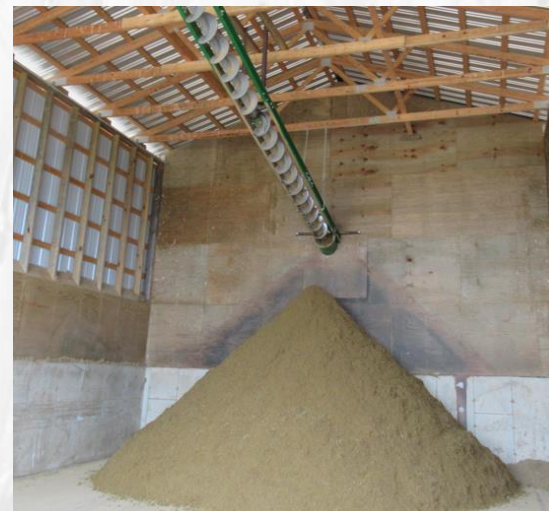
- ▶ Little River Water Quality Management - Farm Agricultural Waste Management Practices Project: implemented best management practices reflecting USDA/NRCS CPS Codes for the subsurface drainage system (CPS 606), leachate collection system (CPS 765I), waste transfer system (CPS 634), waste storage facility (CPS 313), pumping plant (CPS 533) and waste separation facility (CPS 632)

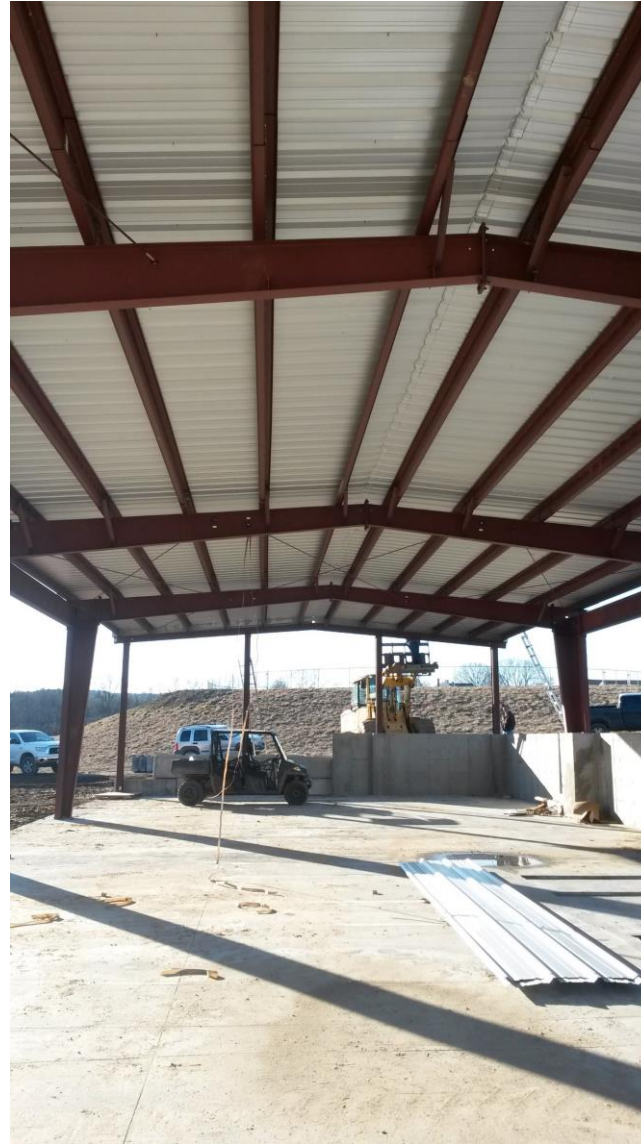
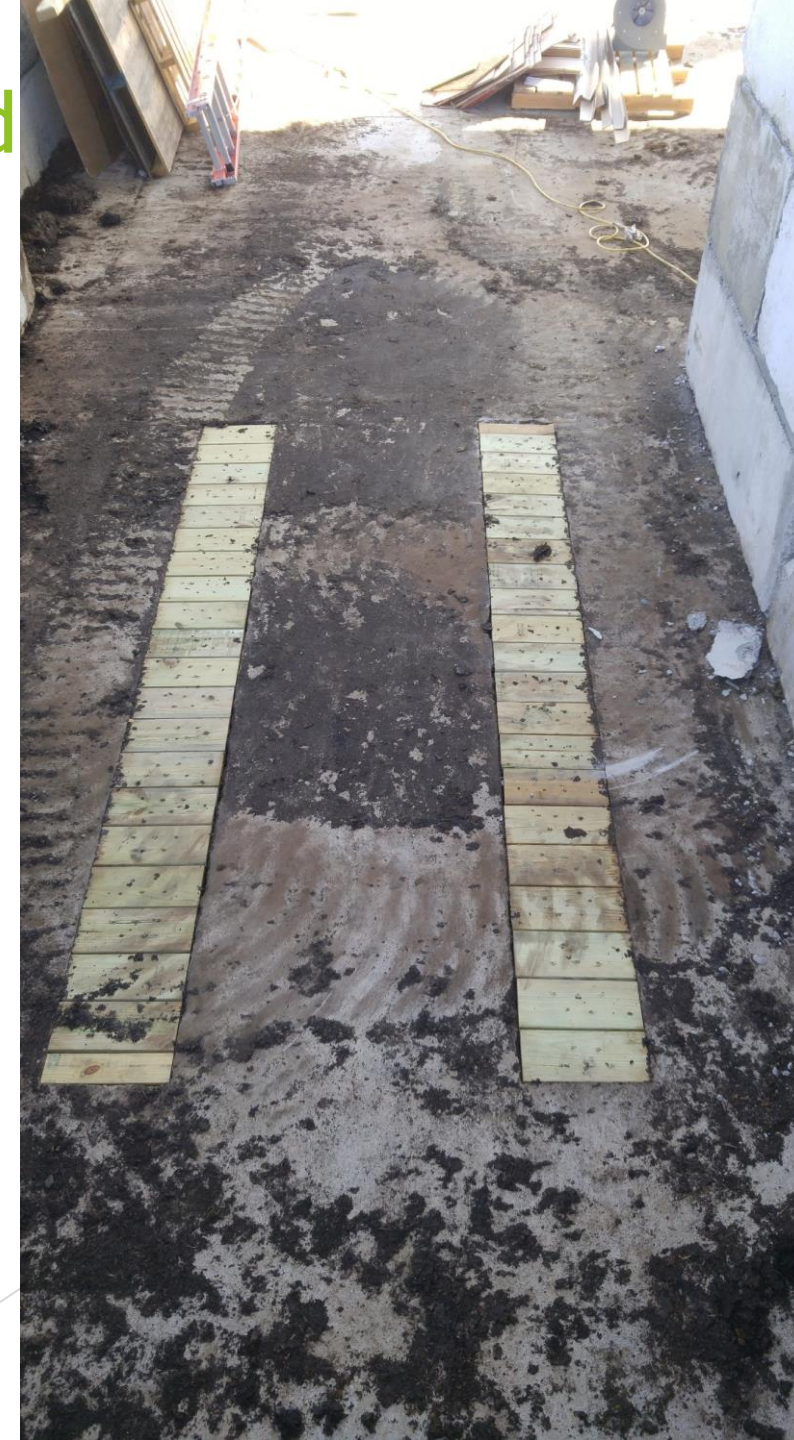
- ▶ Little River Watershed Plan Implementation - Aerated Compost System for Dairy Mortality: constructed an aerated compost facility for dairy mortalities and heifer manure

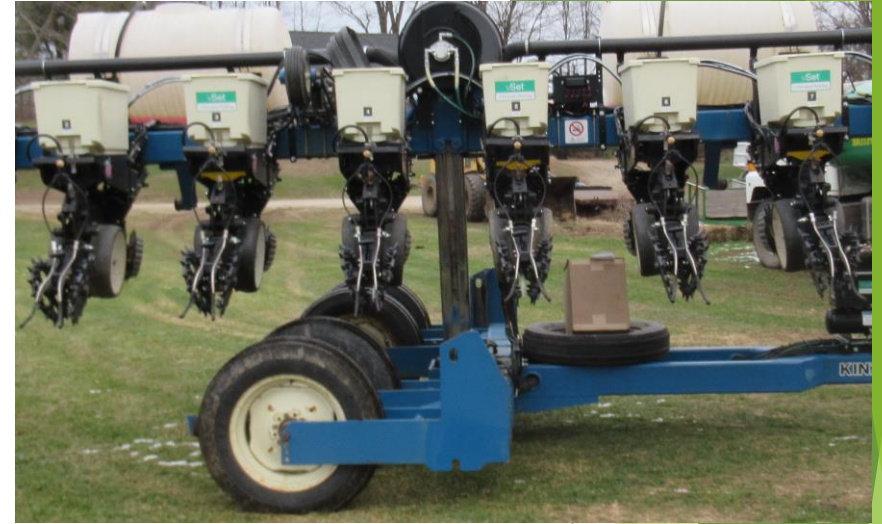
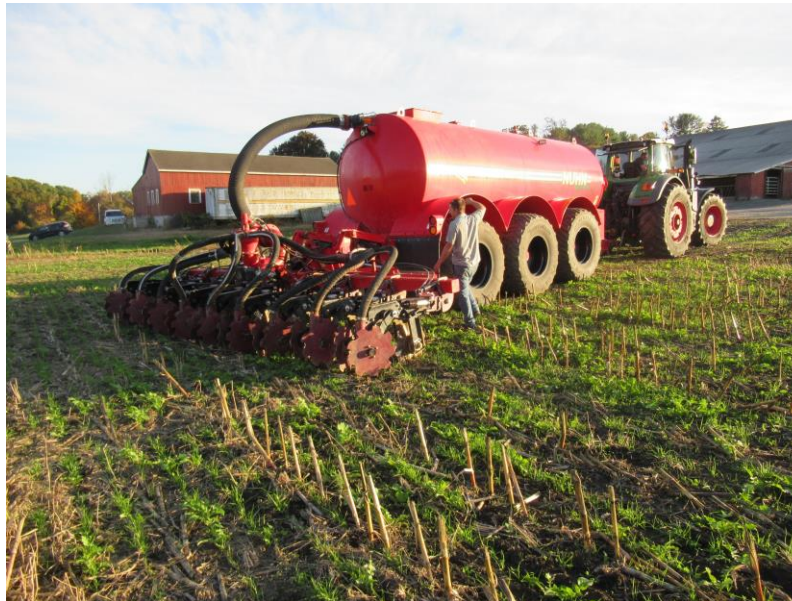
- ▶ Little River Waste Storage Design and Innovative Field Equipment Project: designed a waste storage facility for a farm in Woodstock, CT and purchased innovative field equipment for two farms (manure injectors and precision planting equipment)

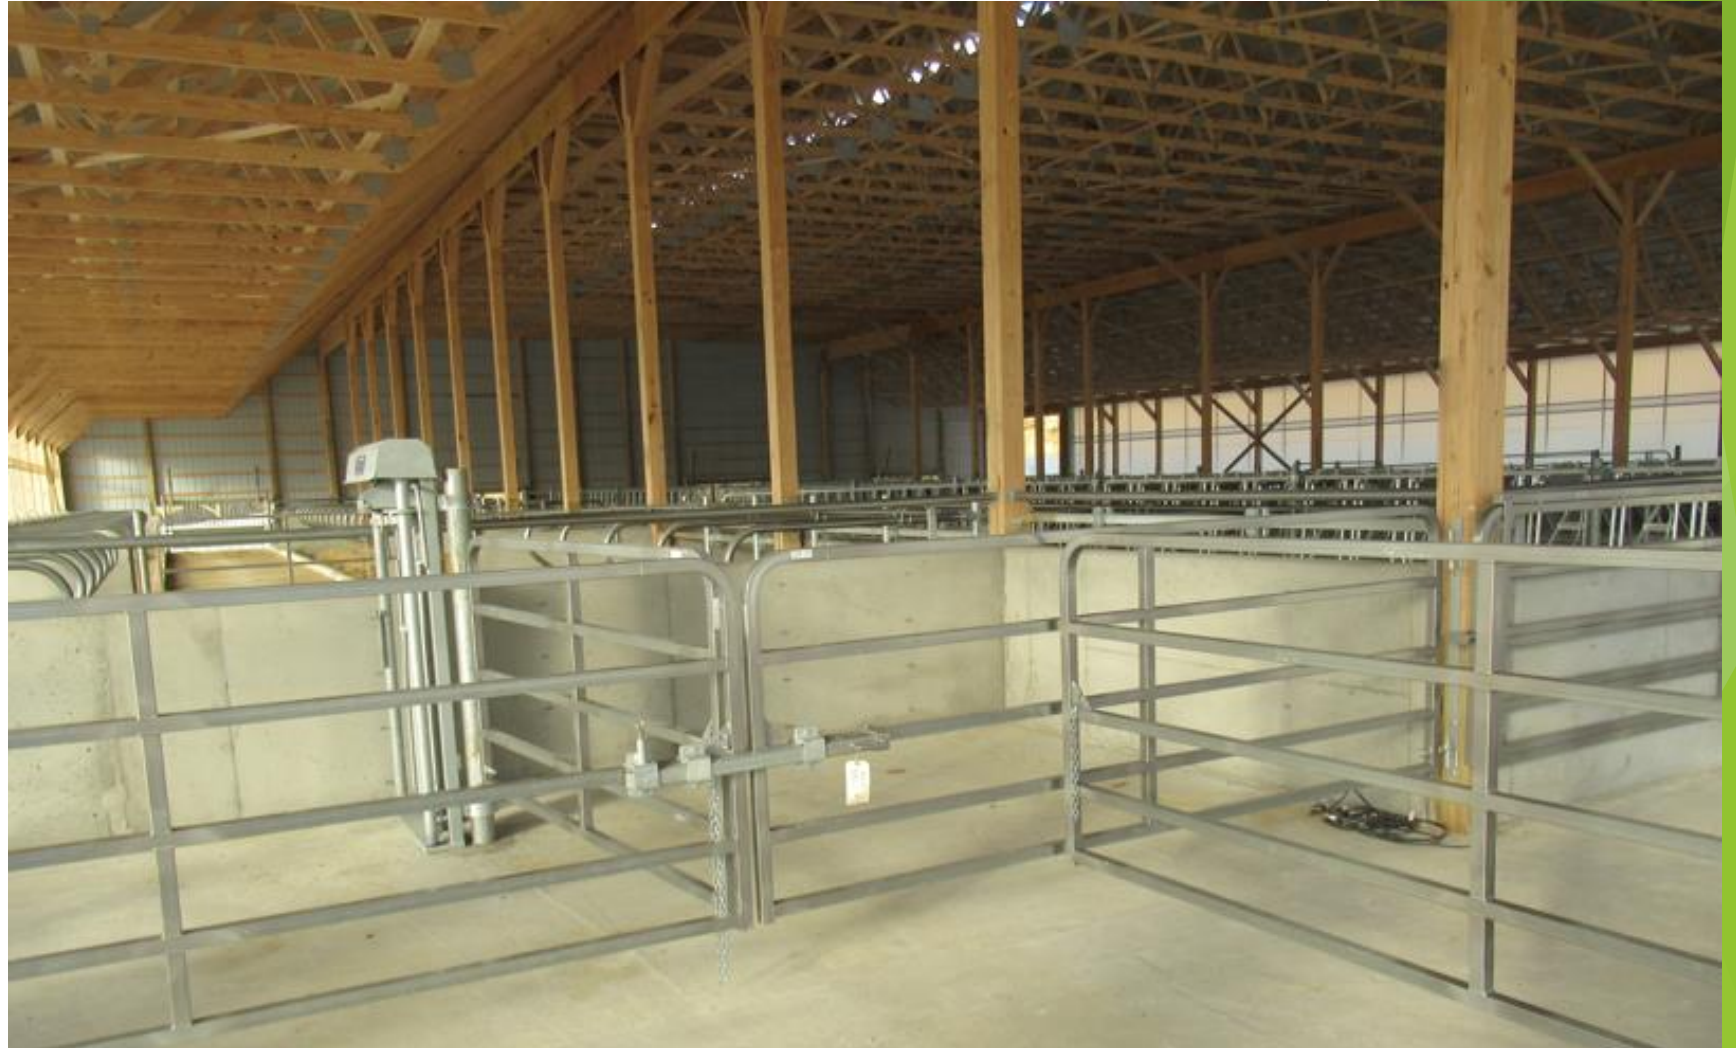
The free-stall barn with agricultural waste storage & management facilities is constructed.

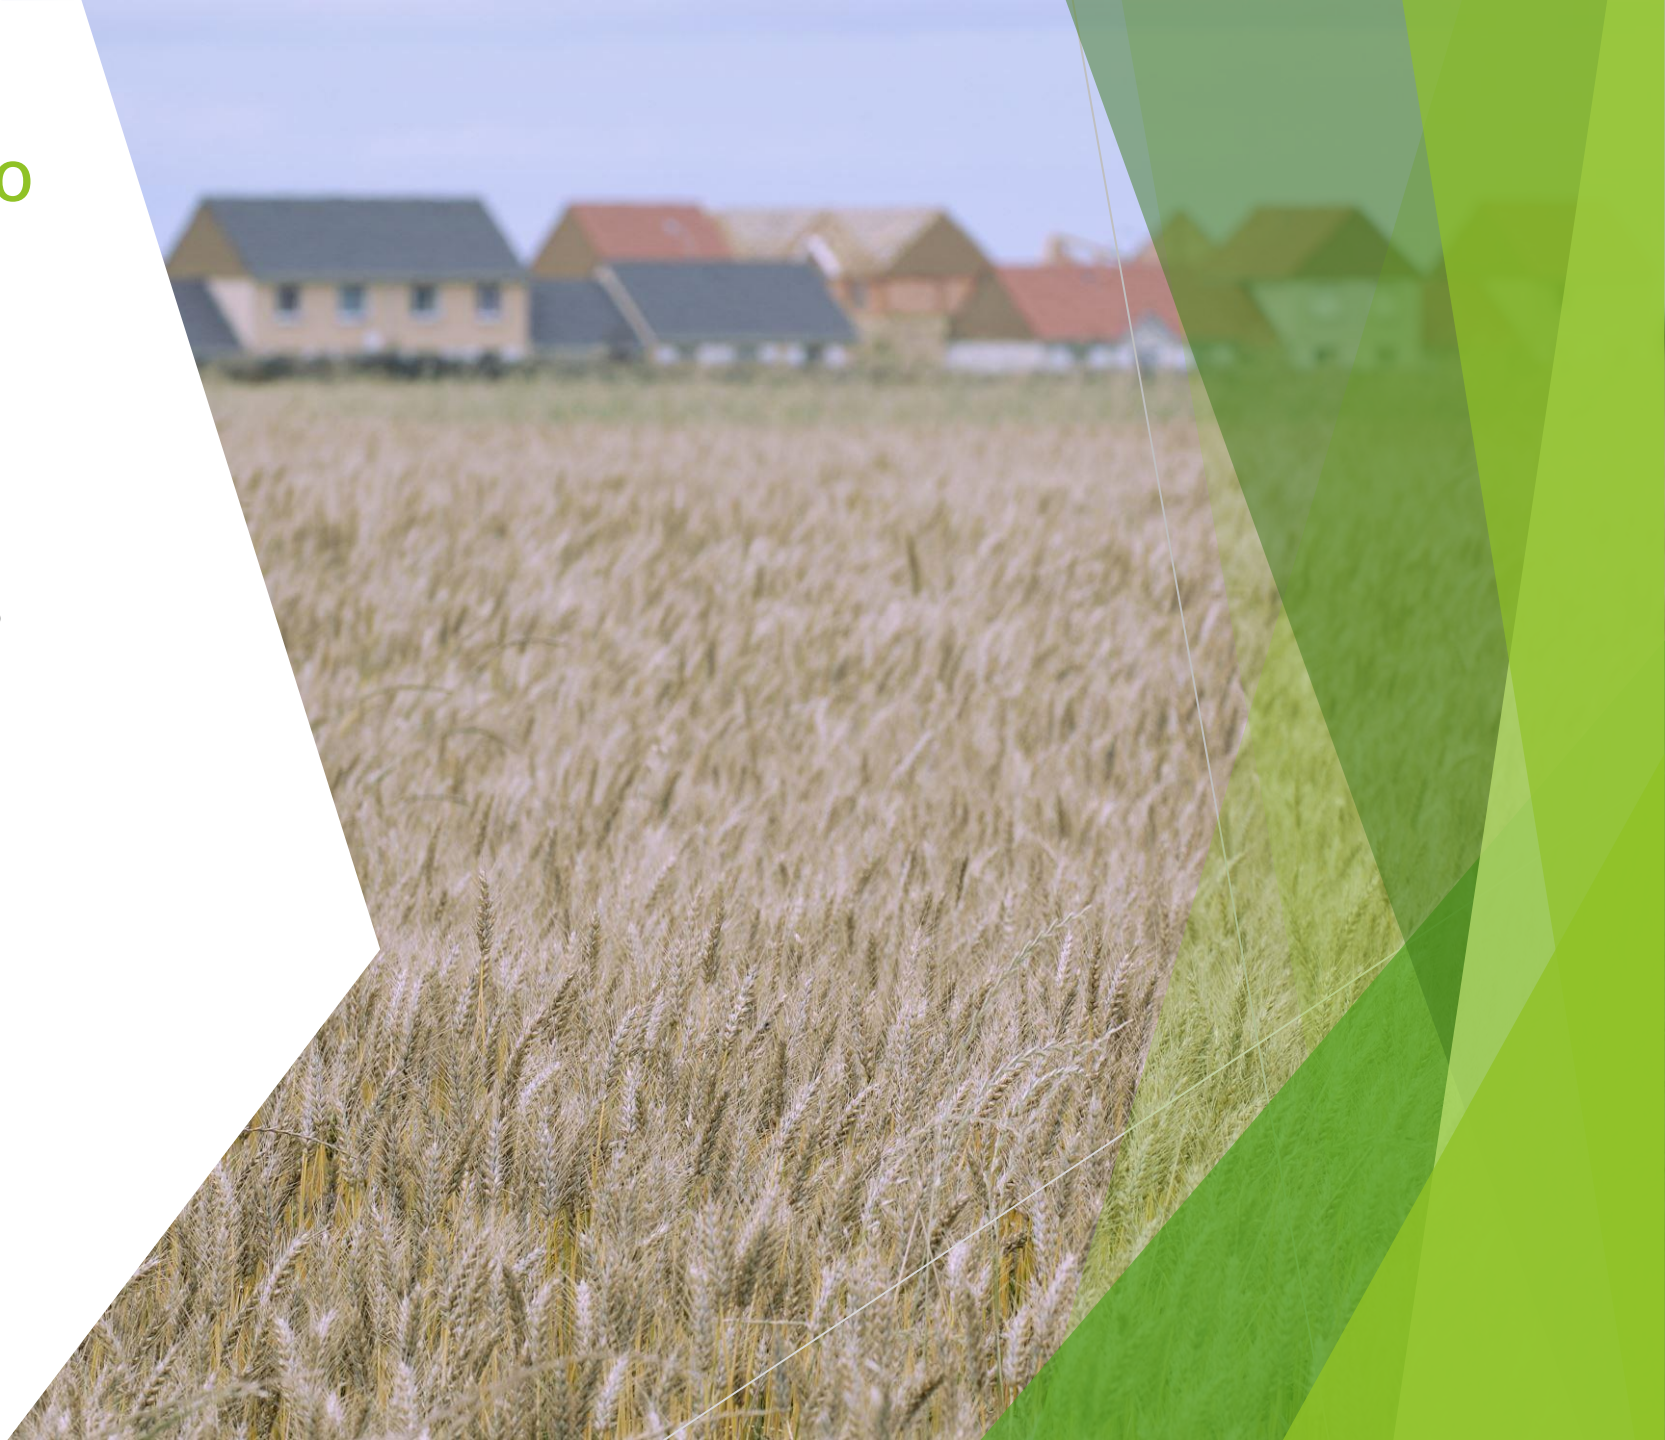
- ▶ ECCD conducted edge-of-field water quality monitoring at 2 sites in eastern CT (farm fields in Baltic and Bozrah)
- ▶ Edge-of-field monitoring conducted using passive stormwater collection boxes known as FirstFlush Samplers

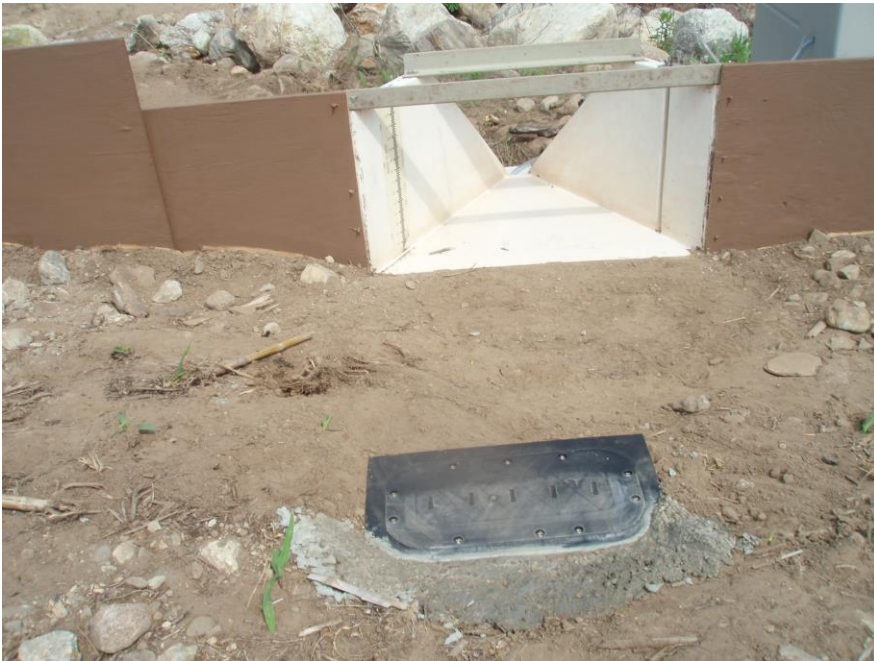
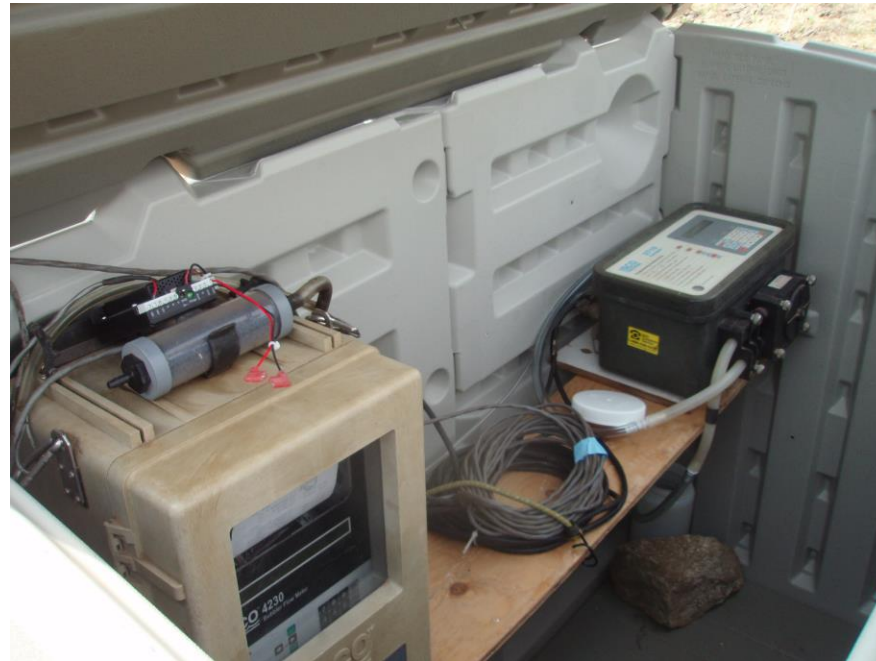
ECCD, in partnership with UCONN, compared ISCO auto-sampling system to GYK passive stormwater collector

Conclusion by Dr. Jack Clausen, UCONN (now retired) was there was no difference in the water quality between the two sampling systems. There was a big difference in the cost between the 2 sampling systems.

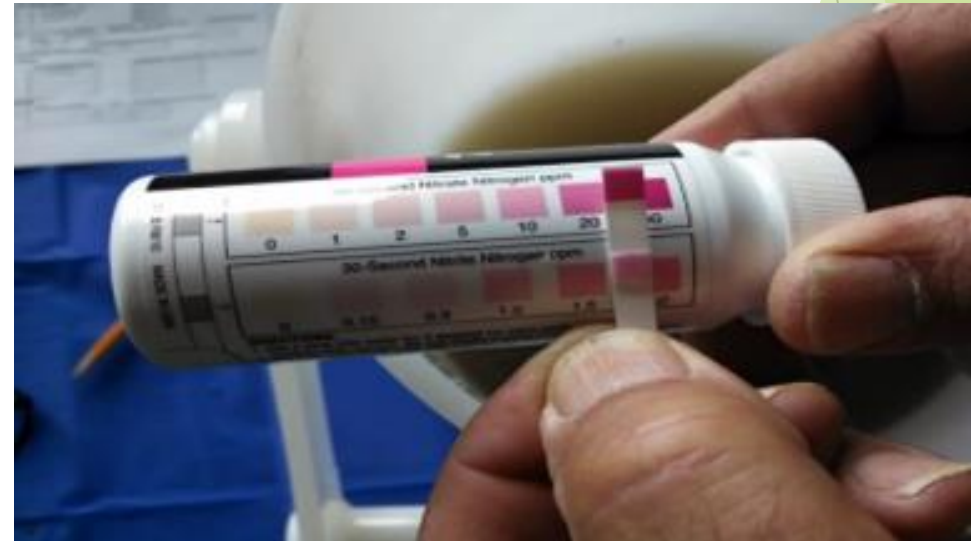
- ▶ HACH test strips for nitrate/nitrite, ammonia and dissolved phosphorus
- ▶ Turbidity Tube for estimating Total Suspended Solids (TSS)

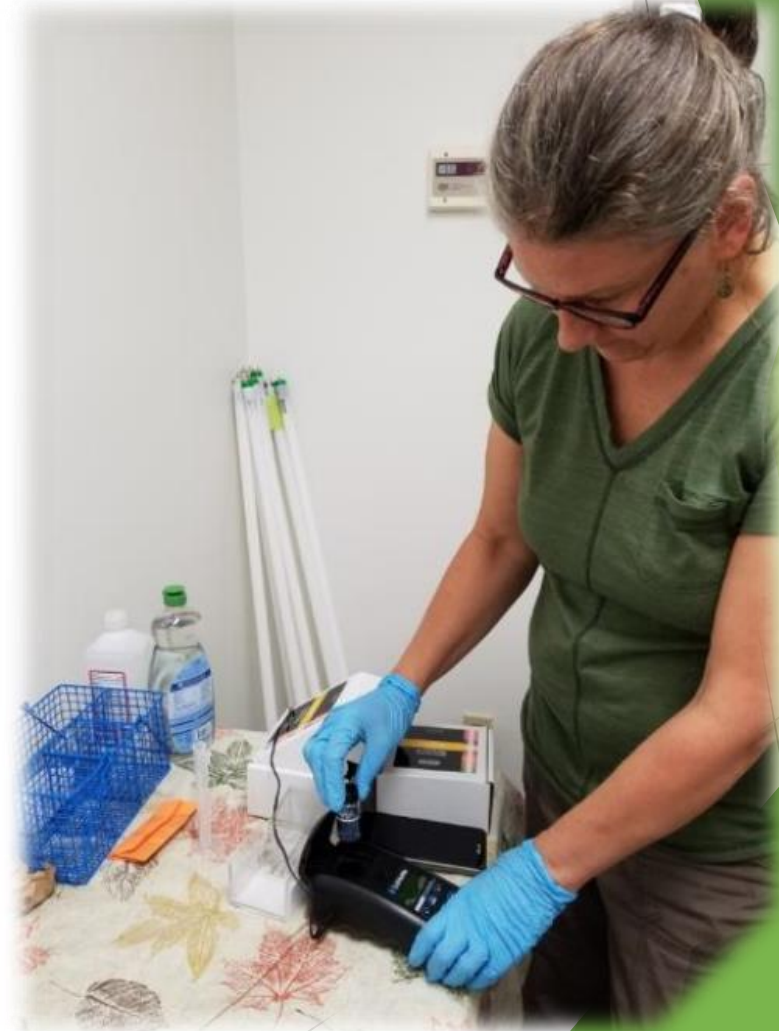
Blank phosphate test strip

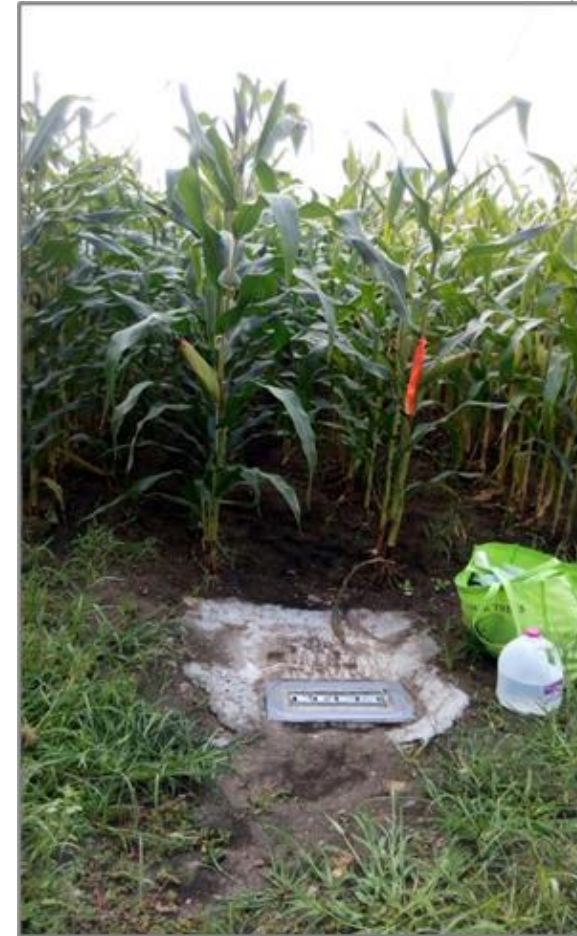
No field buffer strip  
Field sloped  
Noticeable eroded flow channel leading to sampler

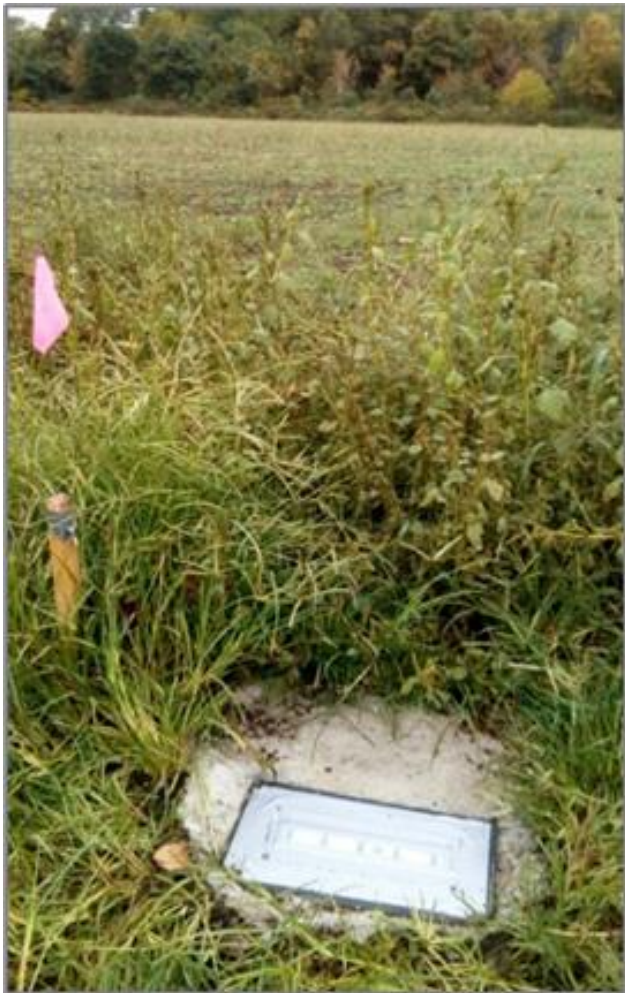
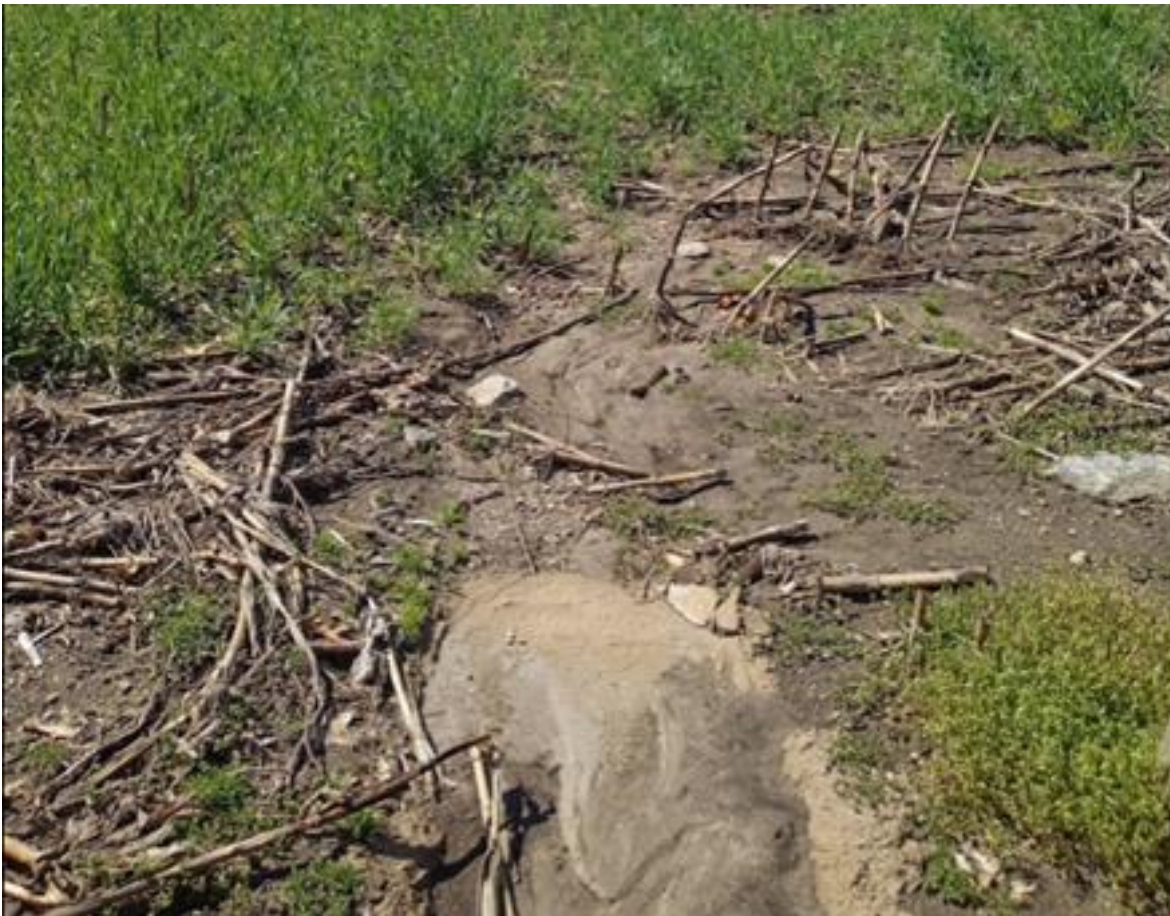
Field Buffer Strip  
Less slope

When the sampler looks like this, it should be obvious you are losing topsoil (and nutrients) off your field.
